Manhole Inspection Summary

Manhole # S21AA_008MH

Location Address: **1712 PARKER CT**

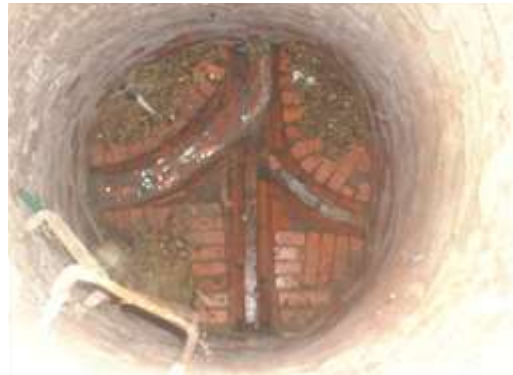
Top View

Offset: **4** (in.)

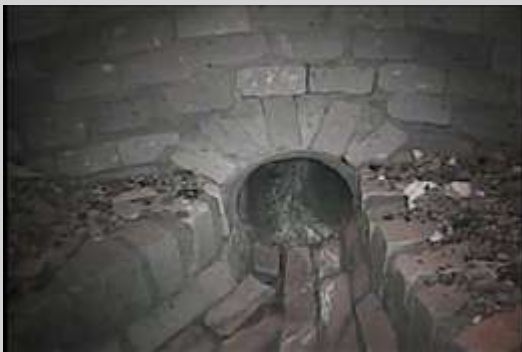
12 O'Clock Outflow

8 in. Circular Gravity Sewer
Pipe Out @ 12 O'Clock

Pipe Height: **8.4** (in.) Rod and Bar (Angled)
Pipe Material: **Clay** ☐ Pipe Lined
Invert Depth: **9.30** (ft.) Flow Characteristics: **Slow**
Deposits: ☒ None ☐ Mud ☐ Sludge ☐ Debris ☐ Grease
Silt Depth: (in.) Deposits Extent:
Infiltration: **None** Pipe Seal Cond: **Sound**

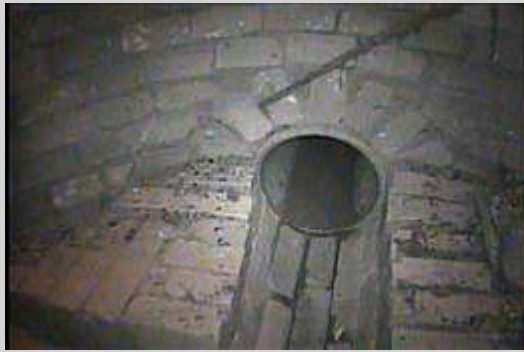
6 O'Clock Inflow

8 in. Circular Gravity Sewer

Pipe In @ 6 O'Clock

Pipe Height: **7.2** (in.) Rod and Bar (Angled)

Pipe Material: **Clay** ☐ Pipe Lined

Invert Depth: **8.75** (ft.) Flow Characteristics: **None**

Deposits: ☒ None ☐ Mud ☐ Sludge ☐ Debris ☐ Grease

Infiltration: **None** Pipe Seal Cond: **Sound**

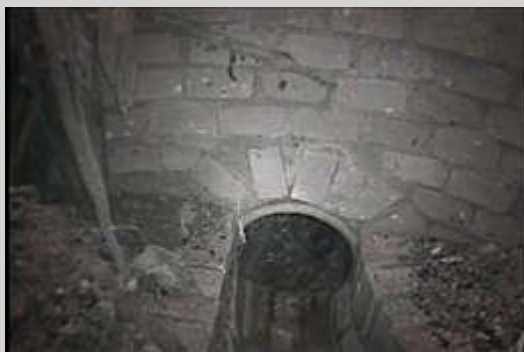
9 O'Clock Inflow

8 in. Circular Gravity Sewer

Pipe In @ 9 O'Clock

Pipe Height: **7.2** (in.) Rod and Bar (Angled)

Pipe Material: **Clay** ☐ Pipe Lined

Infiltration: **None** Pipe Seal Cond: **Sound**
